Navajo Abandoned Uranium Mine

Site Screen Report

Aneth 1 AUM Site

August 2010

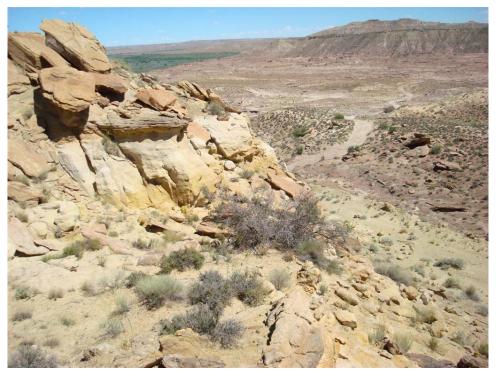
Photo 1. Aneth 1 site, San Juan River in the distance

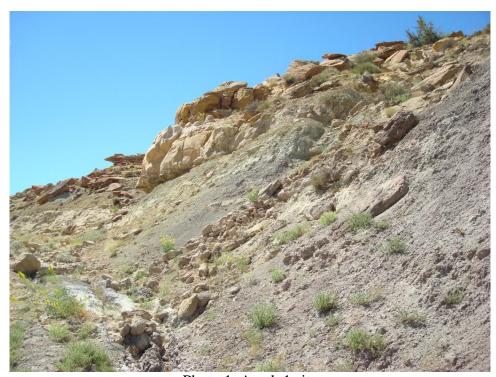
Photo 1. Aneth 1 site
